COUNTRY	Hungary	REPORT	
SUBJECT	Gabor Aron Barracks at Nagykanizsa	DATE DISTR.	2 June 1953
		NO. OF PAGES	3
DATE OF INFO.		REQUIREMENT	
PLACE ACQUIRED		REFERENCES

Sketch of Gabor Aron Military Camp Nagykanizsa, Hungary

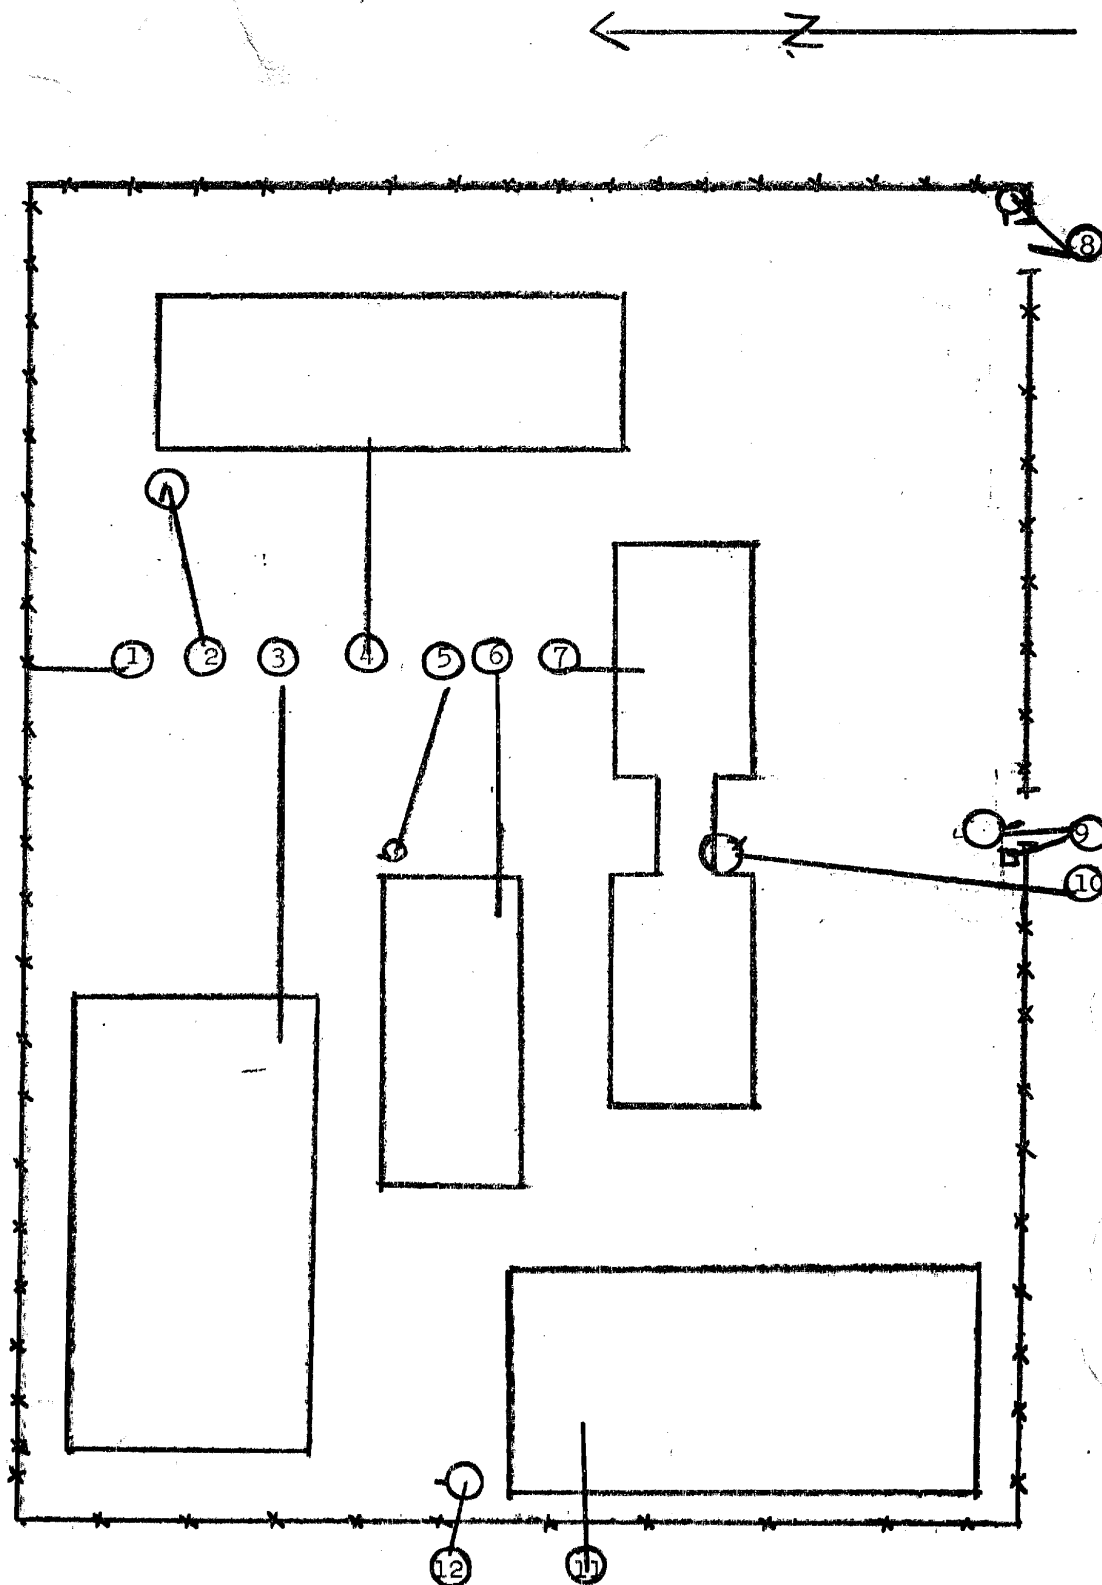
1. Fence, wire mesh with barbed wire top, enclosed camp area 100 x 150 m.
2. Sentry Post #3. Sentry equipped with rifle, guard changed every two hours, post included area west side of building Point 4, this report.

3. Motor Vehicle Garage, reinforced cement construction, flat deck type roof, 30 x 15 x 10 m. Housed 20 GAZ 63 type trucks, 14 weapon carriers (4 wheels, $\frac{1}{4}$ ton.). 1st and 2nd echelon maintenance accomplished here.

4. Building, reinforced concrete, flat deck type roof, 30 x 10 x 8 m., single story, small caliber field artillery guns garaged, number unknown.
5. Sentry Post #4. Sentry equipped with rifle, guard changed every two hours, post included area east of buildings Points 3 and 6.

6. Officers' Mess, concrete reinforced, flat deck roof, single story, 20 x 8 x 10 m., used partly as canteen and officers' club.
7. Headquarters Building: concrete reinforced, flat deck roof, single story, wings 15 x 8 x 12 m., connecting hallway 6 x 3 m. East wing contained Regimental Commanding Officer's offices; West wing, Regimental Staff offices and camp prison.

8. Sentry and Gate, Post #6. Sentry equipped with rifle, guard changed every two hours, post included southeast gate. Passes and leave papers were checked closely.

9. Sentry and Gate, Post #2. Sentry equipped with rifle, guard changed every two hours, post included main gate. Small one-man sentry house. Passes and orders checked closely.

10. Sentry Post #1. Sentry equipped with rifle, guard changed every two hours. This was a stationary post. Sentry checked ID. of persons entering headquarters building, Point 7, this report.

11. Barracks, concrete reinforced, flat deck type roof, basement, 30 x 15 x 20 m., three stories. Artillery troop barracks housing 250 - 300 men.
12. Sentry Post #5. Sentry equipped with rifle, guard changed every two hours, post included area between west fence and building Point 3, this report.

sketch of the Gabor Aron Barracks at Nagykanizsa 4627N-1659E shows this camp. See also Annex A, which pinpoints the location of this camp, among other installations in the Nagykanizsa area. See Annex A attached.
